Status of Thermal NDT of Space Shuttle Materials at NASA

K. Elliott Cramer^a, William P. Winfree^a, Kenneth Hodges^b, Ajay Koshti^b, Daniel Ryan^c and Walter W. Reinhardt^d

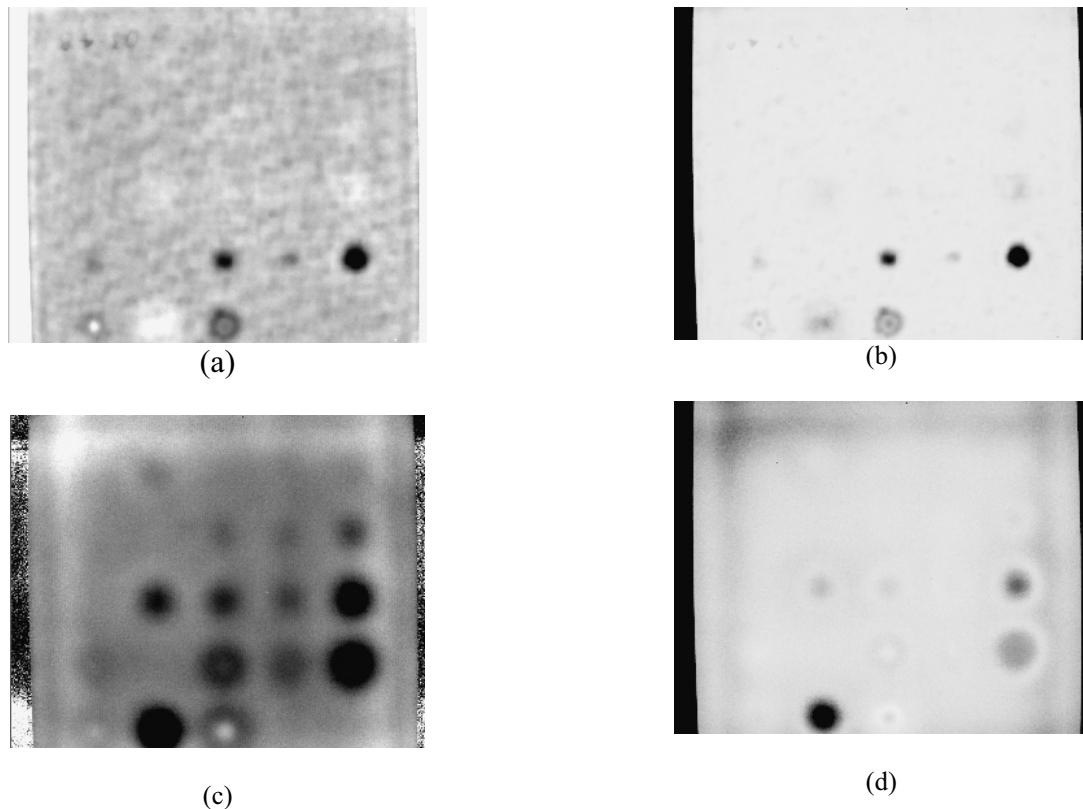
Figure 5 – First (a) and second (b) projection of early time window PCA images of RCC flat-bottom hole specimen processed fixed eigenvectors. First (c) and second (d) projection late time window PCA images of RCC flat-bottom hole specimen processed with fixed eigenvectors.

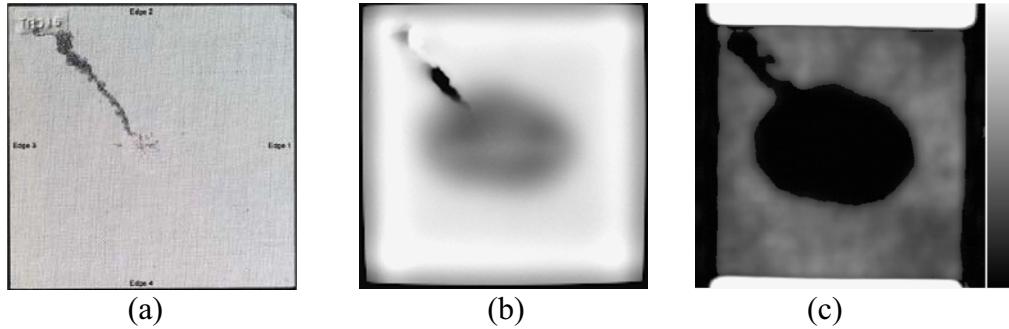
Figure 6 – Results of thermal inspection with PCA processing for a 15cm square RCC specimen impacted on the inspection surface with a projectile at 626 meters per second. (a) Photograph of surface after impact, (b) first projection late time thermal image and (c) ultrasonic pulse echo image of specimen.

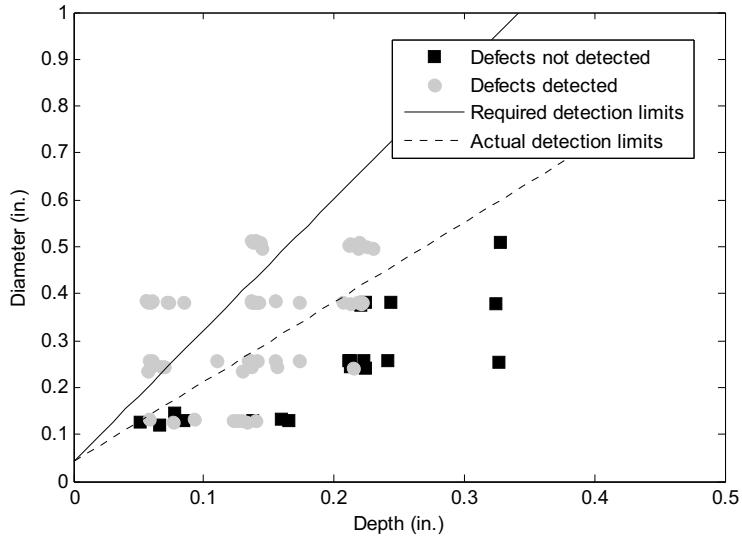
where D is the diameter of the defect and d is the depth. The dashed line is the experimentally determined detection envelope. This testing indicates the system is able to detect flat-bottom hole defects in this structure with the required accuracy of 100% (28 of 28 required defects) for the “straight” hood and 96.4% (27 of 28 required defects) for the “right angle” hood.

Figure 8 – Results for detection of flat-bottom holes in RCC material using the “straight” hood configuration.

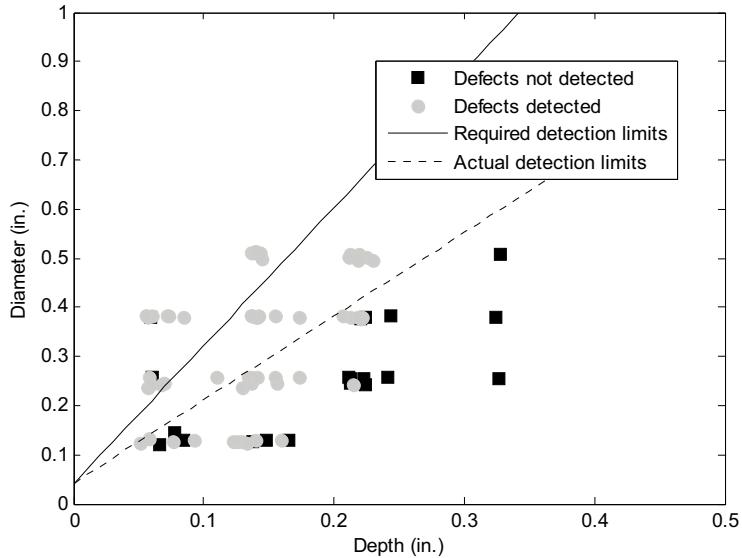
Figure 9 – Performance results for detection of flat-bottom holes in RCC material using the “right angle” hood configuration.

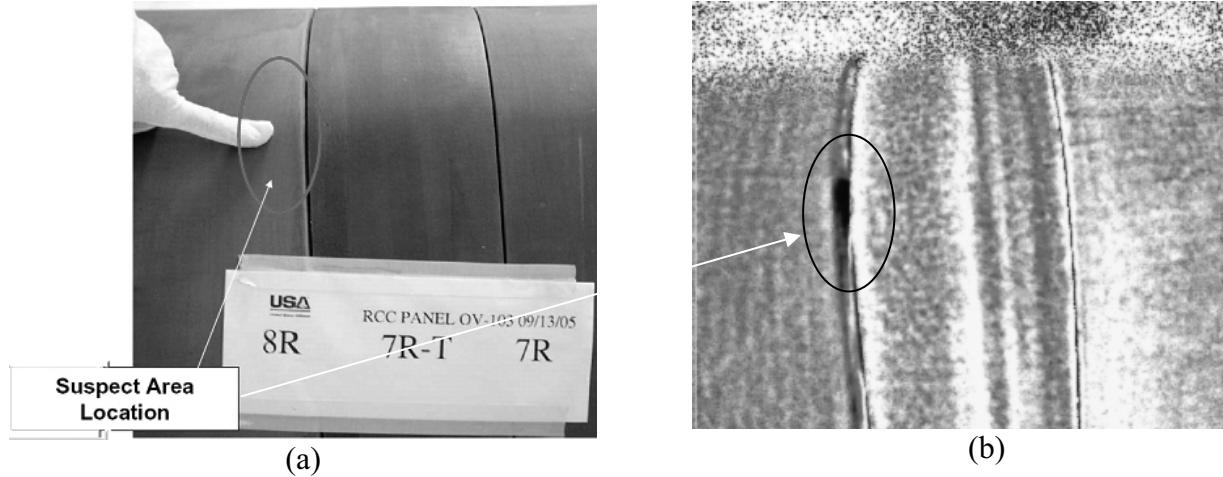
The complete thermography system was applied to the Space Shuttle Discovery upon its return from flight STS-114 in August of 2005. Figure 10 shows the system deployed in the OPF performing an inspection on the left wing RCC material. Figure 11 shows the results obtained during the inspection process. The image shown in figure 11a is a photograph of the inspection region with a suspect area pointed to by an NDE technician. The PCA processed thermal image shown in figure 11b shows the indication consistent with damaged RCC material.

Figure 11 – Typical results of the thermal inspections performed on Discovery. (a) Shows a photograph of the inspection area with a suspect location indicated. (b) PCA processed thermal image of the same area also showing the suspect damage region.
